## The Nisqually Earthquake

#### **Planning the Assessment Survey**

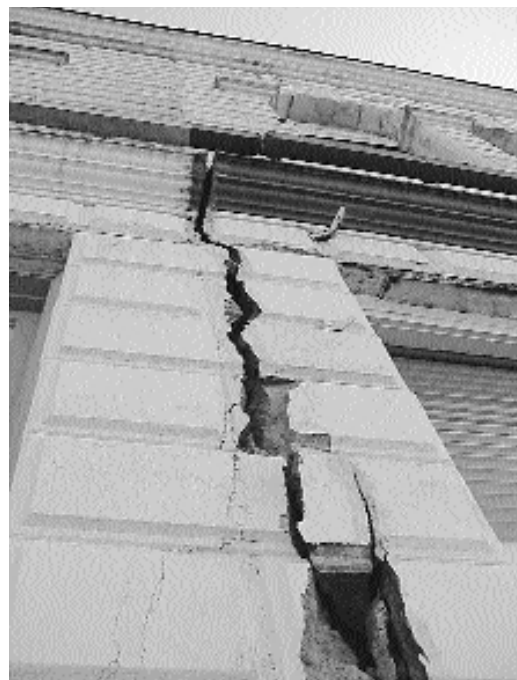
Vertical crack in  
façade pilaster  
on the Aberdeen  
Post Office  
building. Artifacts  
field photo.

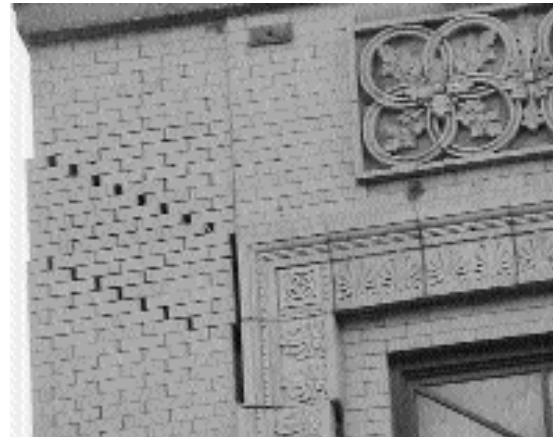
*Upper façade and parapet damage to Cadillac Hotel building, Pioneer Square Historic District, Seattle. Artifacts field photo.*

Seattle's vital Pioneer Square Historic District, where the greatest dollar value damage was experienced, but the best assistance programs are available, several buildings are in jeopardy as a result of opportunistic interests looking for a higher use, among them the venerable Cadillac Hotel.
